## 4. DESCRIPTION AND CONDITION

The heritage values of the RG Menzies Building are largely embodied in the physical fabrics of the place, how the building is used, and how the building is positioned in the landscape. The following section provides a detailed description of the building and grounds, as well as information on the condition of the separate elements.

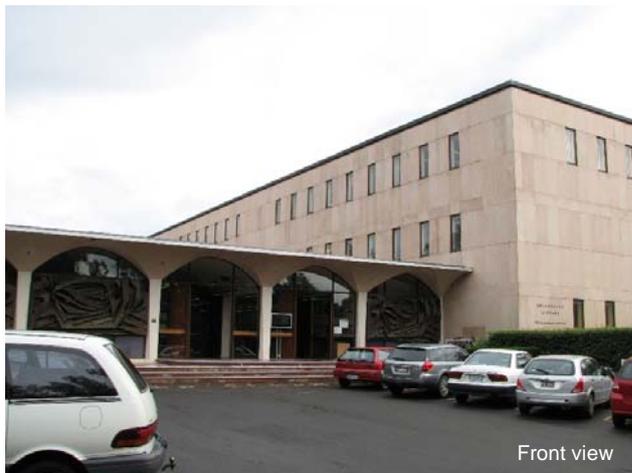
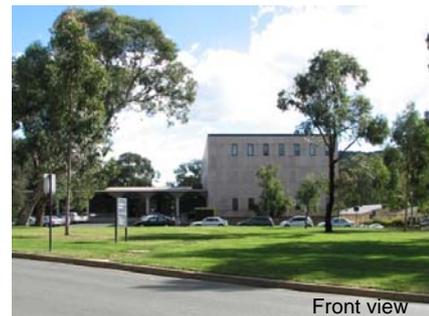
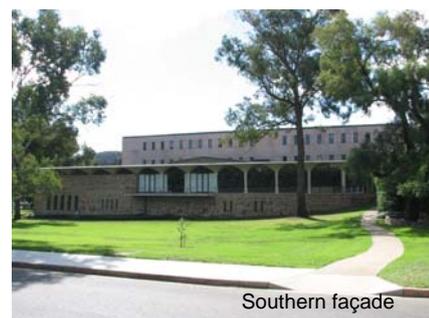
Front view

**Figure 4.1:** The Menzies Building is formed of two very distinct elements; the low southern block and the northern book stack block (above). The building is open to the north, west and south, with views of Black Mountain to the west.

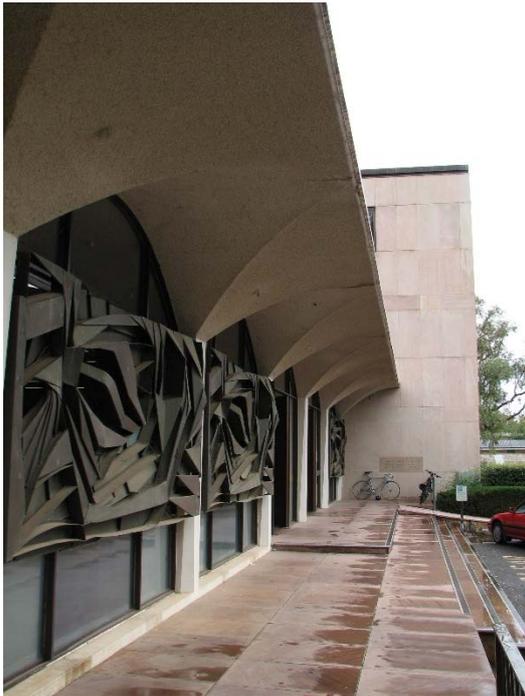
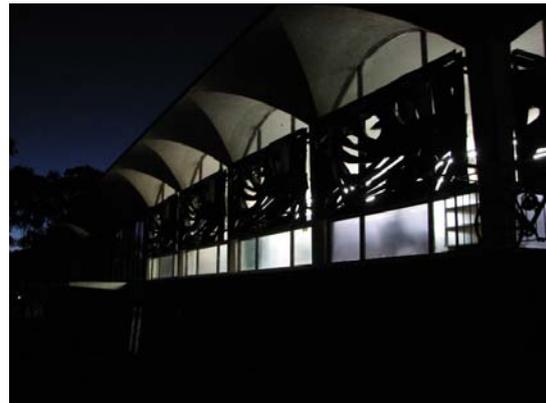
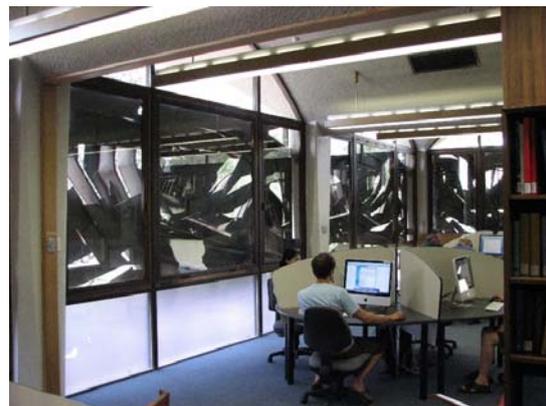
The stone plinth is a major architectural element of the southern block and extends to the height of the roof. The fenestration is punctuated by large windows covered with the decorative Dadswell 'Screens' and other more narrow windows providing light for the lower ground floor on the southern and western sides of the building. The southern section sits beneath a concrete vault ceiling and copper roof with no eaves. The lack of downpipes, which are actually embedded in the structural columns, are a notable feature that provides for an unending run of the roof edge. The roof is clad in copper sheeting which is joined at the folded seams. A light artificial membrane has recently been affixed atop the copper sheeting in order to correct the design flaws while also protecting the original roof fabrics. The roof of the enclosed courtyard is formed of a lighter shade of galvanized steel and sits about 2ft. above the original copper roof. This element does not detract from the appearance from surface level, though is clear from the upper storey windows. The walls and roof of the southern block require only minor repairs; no damages were seen that detract from the architectural or aesthetic qualities of the place. However, the west side of the southern block has been stained; likely from nearby eucalypts.

**Figure 4.2:** Lyndon Dadswell was a renowned Australian artist. His 'Screens', used as both a sunscreen and decorative element, are one of the significant features of the Menzies Library.

- Examine the nature of the stain on the rear wall; this stain appears to be the result of impact from nearby eucalypt trees. No trees will be removed to remedy this problem

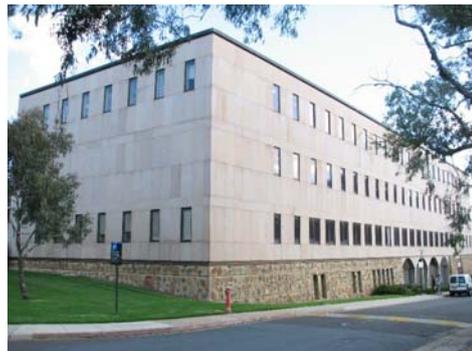
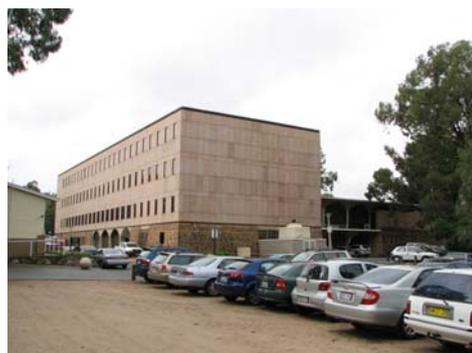
The northern block is a four-storey structure set on a stone base identical to that of the southern block. It is clad with sawn sandstone that leads to a copper pan roof with no eaves. The copper roof is in good condition; it has not been overlaid with membrane as part of the recent works. The stonework requires some minor cleaning, though generally is in very good condition.

A regular pattern of small vertical slit windows, framed in aluminium (or bronze?), line the north and southern fenestration, with some also added to the ground and second floor of the front façade (Figure 4.3). Heavy steel venting provides circulation for the lower ground floor plant room and the lower floor of the northern block near the rear entrance. The vents on the western wall provide a partition between the large air-conditioning tower, which is also screened in identical steel vents. The tower also services the buildings of the Chancelry and the Faculty of Law.

The windows found throughout the northern block are single panes with casement sashes, complementing the copper roof and screens of the southern block. The frames,

**Figure 4.3:** The northern block sits on the same stone plinth as the south block. Both north and southern faces are lined with aluminium or bronze framed windows. Views are of the front (above) and rear of the north block.

with bronzed appearance, blend well with the surrounding facing. The sealing around these windows must be examined and, if necessary, repaired.

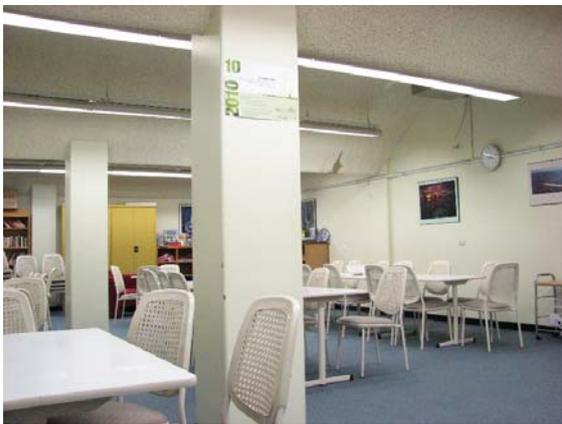
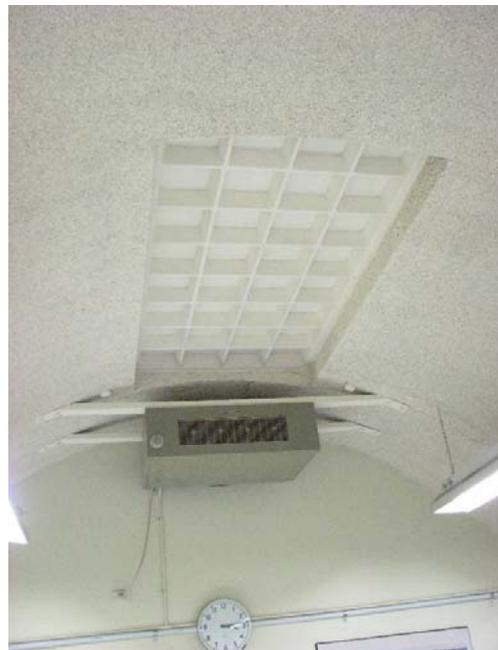
**Figure 4.4:** The old Duplicating Room has been converted into the staff common room. The pavement sunlight fittings, still seen on the ceiling (right), were a cause of concern in the early design and were one of the reasons the courtyard was enclosed in the late 1970s.

Some original fittings, joinery and furnishings have been retained in the basement level, although there have been notable modern additions. These include new carpets and light fittings and carpet laid to the underside of the concrete vaults. The current staff tearoom was originally the Duplicating Room

(Figure 4.4). It still showcases the vaulted ceilings with vermiculite coating though any evidence of the original use has been removed. The size of the room itself has not been altered. An interesting remnant feature are the pavement light covers in the ceiling that originally provided sunlight from the courtyard; stains from the water that leaked through the pavement lights are still visible on the vermiculite.

- Clean water staining on vermiculite ceiling in public areas; staining to vermiculite ceiling in basement staff common room should be retained in association with pavement light fittings from enclosed courtyard

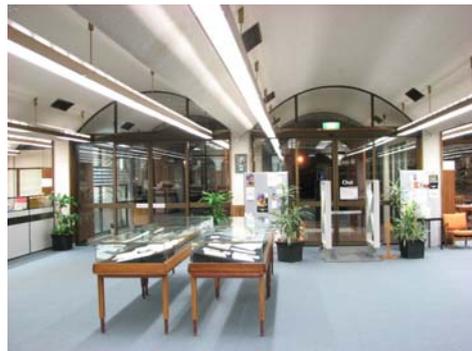
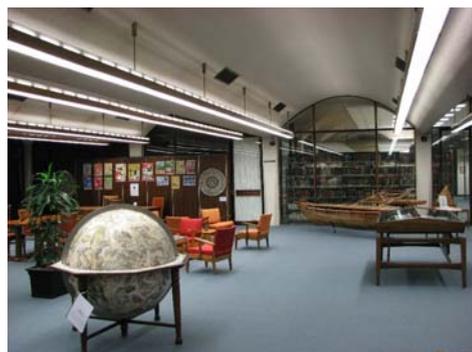
The foyer has recently seen refurbishments that have opened out the area. Semi-permanent display cabinets are set in the middle of the room, forming a separation between the entrance and exit doors. The display cabinets, part of the furniture collection of the building, are an arresting feature of the space. A large globe sits in the centre of the room; it was originally purchased for the Menzies Building, though has been a feature of the Chifley Library in recent years. The globe was returned to the Menzies Library as part of the refurbishment.

**Figure 4.5:** The foyer is the central point of focus of the Menzies Building and showcases many original elements. These include the concrete barrel vaulted ceiling and vermiculite coating, bronze and timber finishes and original Ward furniture.

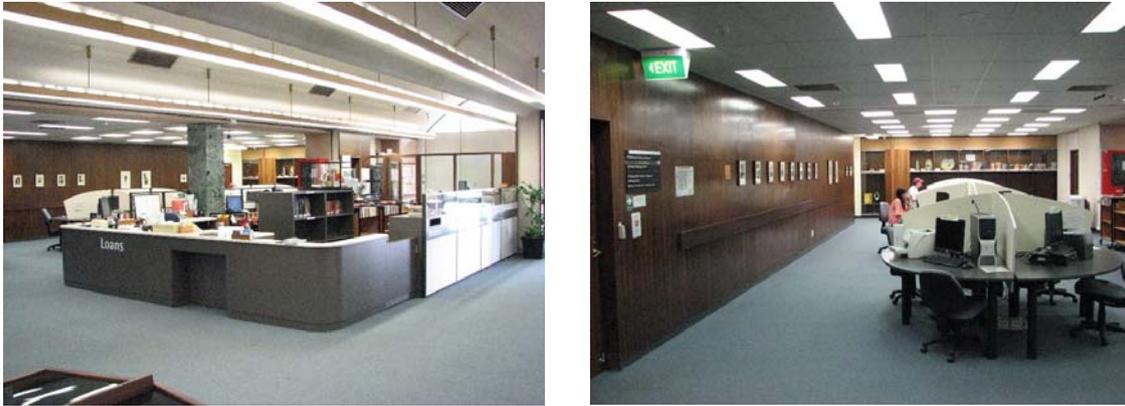
**Figure 4.6:** The loans desk (left) is a modern addition; the ground floor of the southern block (right) showcases original paneled timber cladding and in-built cupboards

Much of the foyer area has been filled with study carrels and computer terminals. There is also some relaxed break-out areas with (Ward?) chairs and desks, and a large central modern loans desk (Figure 4.6). The original loans desk sat directly opposite the main entrance, though was removed about eight years after construction. It has been gradually updated ever since. Timber glazed partitions, not original, have been installed behind the loans desk to provide semi-formal office space. The loans desk itself is in good condition.

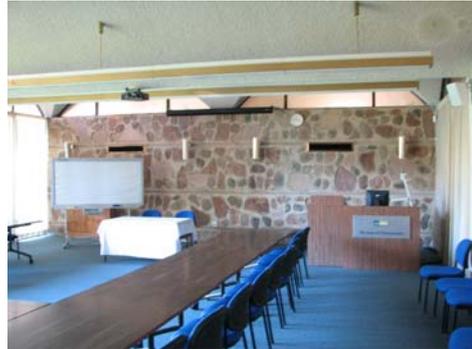
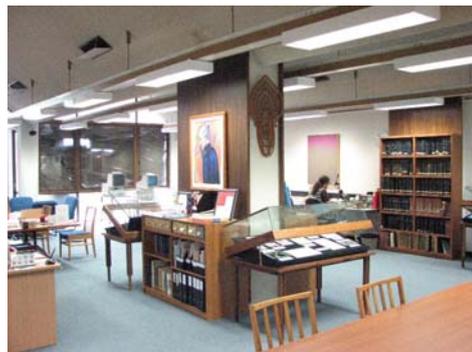
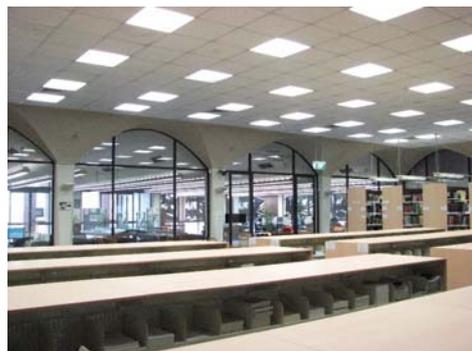
The McDonald Room, seemingly built as a seminar room but used for exhibitions, is lined in timber. The west wall is a feature wall formed of the same strongly textured raw concrete and stone used for the building plinth. This feature was originally continued as the west wall of the courtyard, though has since been removed. Joinery is dark-stained timber, with brass fixtures throughout. The sliding doors leading to the external verandah are glazed panels set in copper frames. This room is today used mainly for seminars or meetings, with some

intermittent use for exhibitions. It is in good condition and, apart from modern furniture and audio-visual installations, is highly intact.

The enclosed courtyard room is a high, open space. The ceiling infill is of basic fibro panels that are a contrast to the barrel vault ceiling seen elsewhere in the building. The original doors and windows are formed of glazed panels in aluminium/bronze frames running the full height of the space. These are original features; early occupants often complained about the amount of glare penetrating their offices from the courtyard, as well as water entering the building beneath the door frames. The light modern bookshelves in this area are used for Asian reference books and some serial display cabinets, with room set aside for readers on more 'traditional' furniture.

The Noel Butlin and ANU Archives Reading Room is a large open space that originally formed the southern end of the serial stack area. It showcases a central supporting pillar that is again lightly clad in timber. The barrel-vaulted ceiling and window finishes are identical to those of the foyer and McDonald Room. The windows of the western side, above the verandah, are clad externally in Dadswell's screens. A large open office, tea-room and some office space has been formed with light modern partitions to the south of the reading room for the archives staff, and again showcases the barrel vaults of the ceiling and copper finishes. The reading room and office area is separated by a semi-glazed wall.

The Archives Reading Room has some traditional timber shelving as well as modern shelving. The more traditional chairs and tables do not appear to be Ward pieces, though are highly reminiscent of his style. The staff offices have been fitted with modern computer desks, with space set aside for compactus and other shelving for photographs and archives that are currently being used.

**Figure 4.7:** Notable rooms of the ground floor include the McDonald Room with stone feature wall (above), the Archives Reading Room (centre) and the enclosed courtyard, showcasing an obvious departure to the barrel vault ceilings seen elsewhere in the building (below)

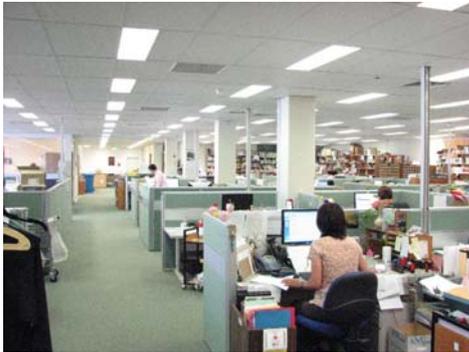
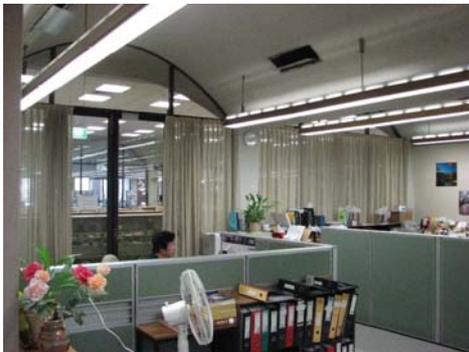
The ground floor/foyer area of the northern stack block has been left open and fitted with study carrels and computer terminals. This area is much more dark than that of the southern block, due largely to the lack of natural sunlight permitted to the space, the grey-green marble terrazzo affixed to supporting columns and dark-stained timber lining the western and southern walls near the central staircase (Figures 4.6 & 4.10). The supporting columns sit on octagonal bases with square capitals.

**Figure 4.8:** The ground floor of the northern block has been left open and fitted with office cubicles

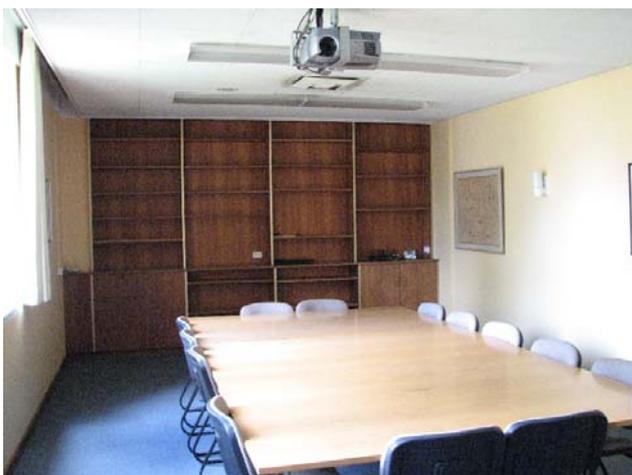
**Figure 4.9:** Original features, including shelving and joinery, have been retained in the old Librarian's office, which has since become a meeting room

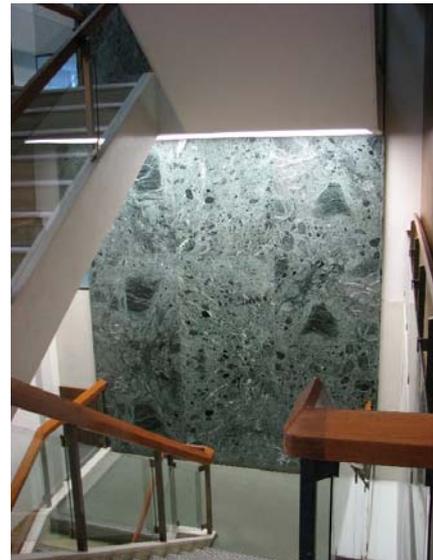
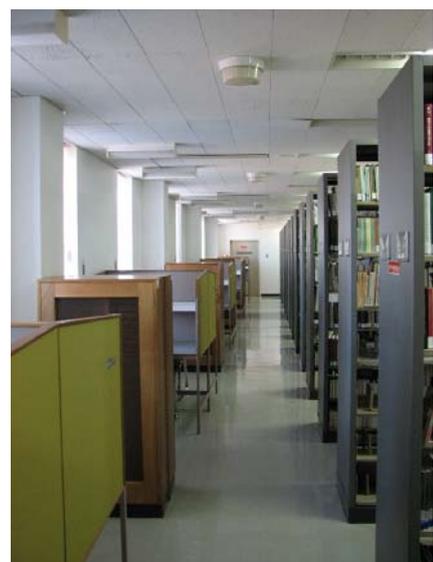
The central staircase of the building is highly original, though does display signs of wear and minor damages. The concrete stairs have metal treads and are flanked by glass and brass balustrades with angled and stained timber handrails. Arresting features of the staircase are the terrazzo finishes applied to the facing wall, matching that of the columns on the ground floor. This motif is continued for each landing (Figure 4.10).

**Figure 4.10:** The main staircase displays marble terrazzo feature walls (above), leading to the book stacks on the upper floors (below)

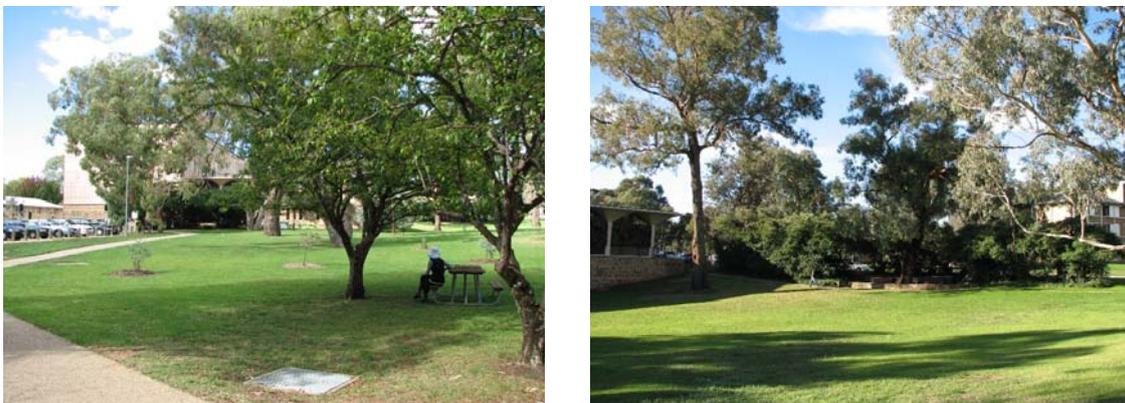
An interesting component of the landscape is the barbecue area to the southeast of the building. This space is formed of the identical stonework to that seen on the building and is regularly used by University staff.

**Figure 4.11:** The landscape to the west (left) and the small barbecue area to the south of the Menzies Building.

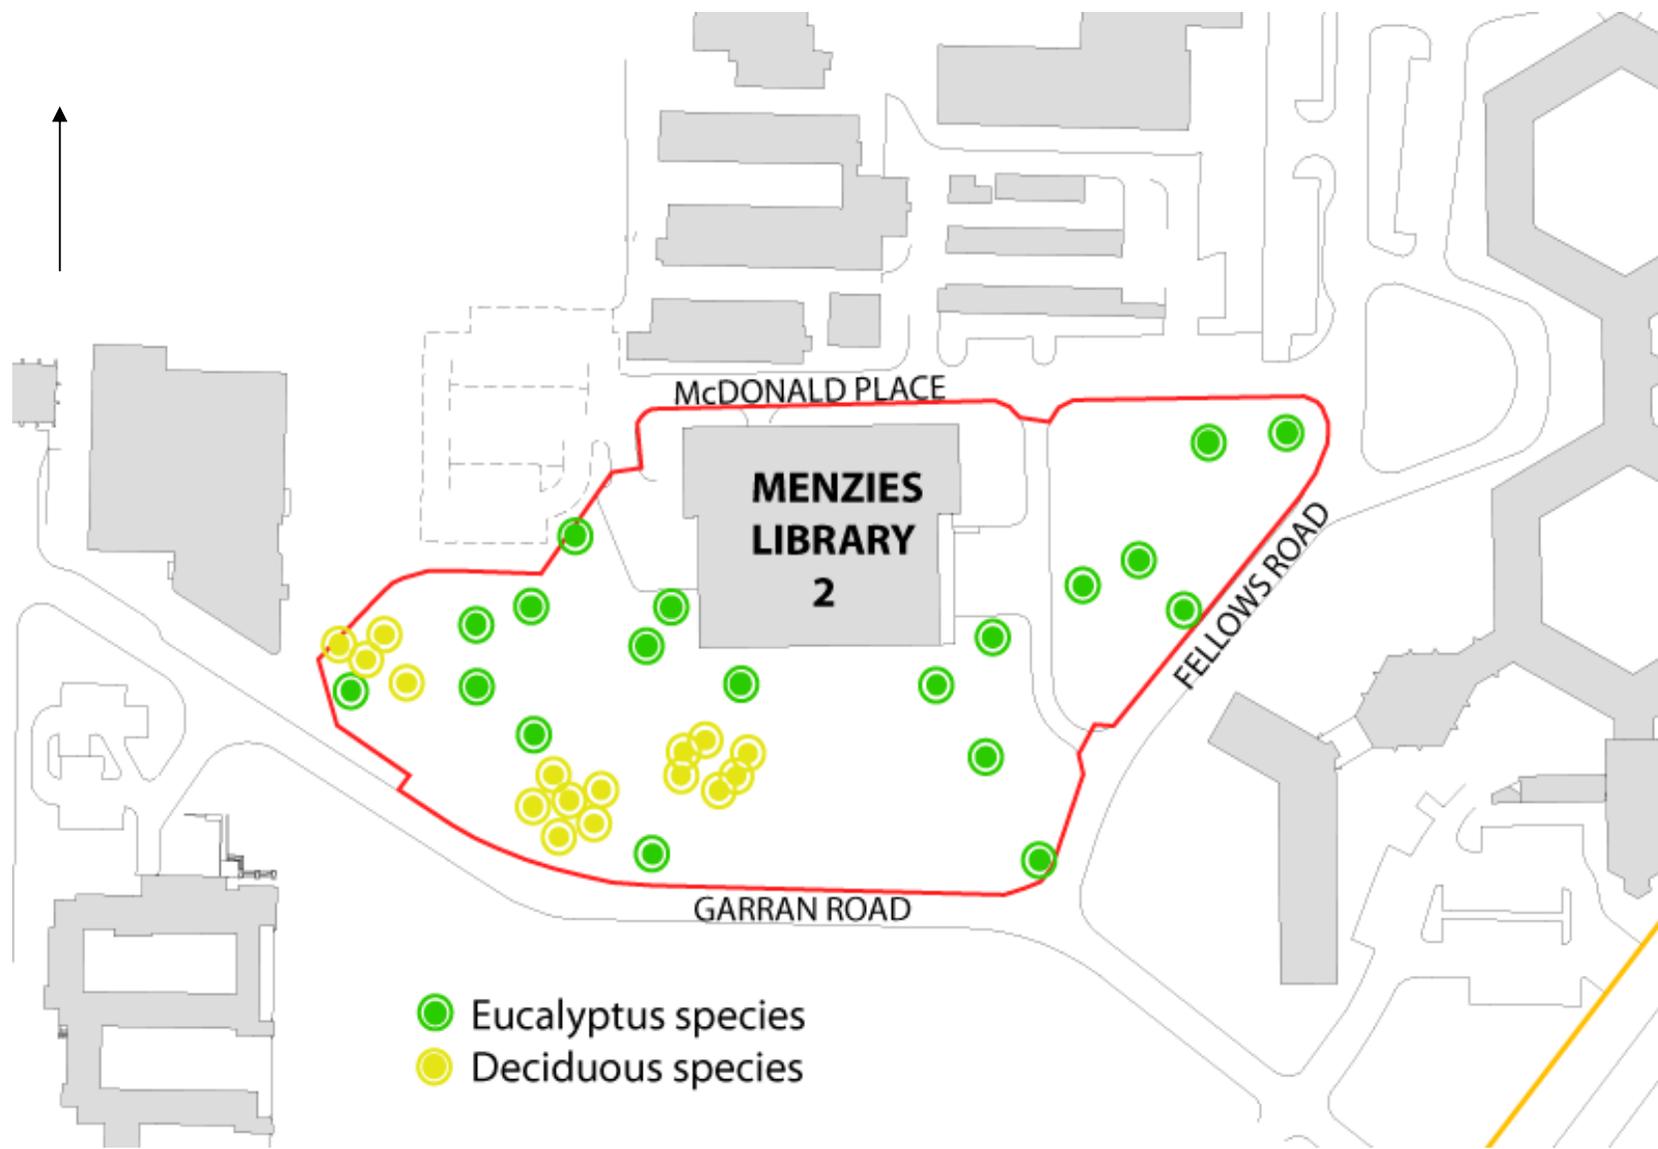
The landscape is formed of open (European) grassland with remnant indigenous trees and some introduced species. Highly significant trees are found to the south and east of the building (Figure 4.12). They mainly consist of Eucalyptus species, with some deciduous *Malus* in pockets to the south of the site. A number of mature black poplars are also visible, with a single example of a notable Banksia species.

Figure 4.12: Notable tree species of the curtilage area (ANU Gardens & Grounds Division, 2010)

- Investigate feasibility of installing solar cell panels on upper copper roof; no original fabrics should be damaged
- Monitor condition of significant landscape elements in conjunction with ANU Gardens & Grounds Division

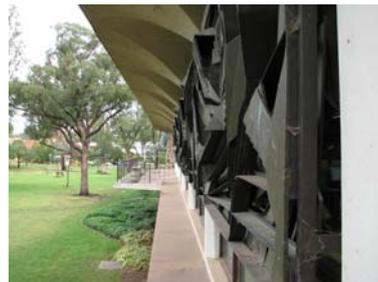
The attributes are the two distinct architectural elements, a low-level pavilion and three-storey block of the RG Menzies building and the metal sculpture 'Screens' by Lyndon Dadswell located on the façade of the building.

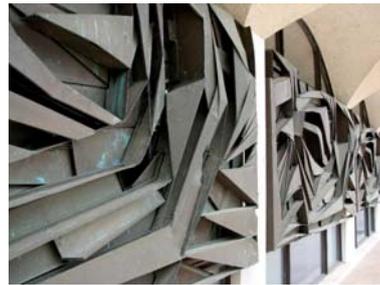
The metal panel sculptures integrated into the design of the building are significant as a major work by the nationally recognized artist, Lyndon Dadswell. Dadswell is considered a pioneer of Australian sculpture, in particular for his innovative use of metals. The sculpture acts as both a decorative element for the exterior and a functional sun shield for the interior space of the library.

The attribute is the metal panel sculpture 'Screens' by Lyndon Dadswell on the façade of the RG Menzies building.
