Study Item/ Area	Drill Hall Gallery
Acton Campus Precinct	KINGSLEY Precinct
Building Nos. & Names	29 (Drill Hall Gallery)

Heritage Ranking	Drill Hall Gallery— <b>Exceptional</b> —Commonwealth Heritage value
Heritage Listing	The Drill Hall Gallery is listed on the Commonwealth Heritage List (Place ID: 105635) The Drill Hall Gallery is also nominated for the ACT Heritage Register, included on the Australian Institute of Architect's Register of Significant Twentieth Century Architecture (Place ID R059), and is also included on the ACT Heritage Register (Place ID AC0035).
Condition—Date	The condition noted here is at December 2011. The extant building and trees of the Drill Hall Gallery continue to be well maintained for exhibition and office accommodation and are in reasonable condition.
Relevant Documentation	2010 Heritage Management Plan for the Drill Hall Gallery has been prepared by the ANU Heritage Officer. It provides a detailed history and description of the buildings within the Drill Hall Gallery vicinity.

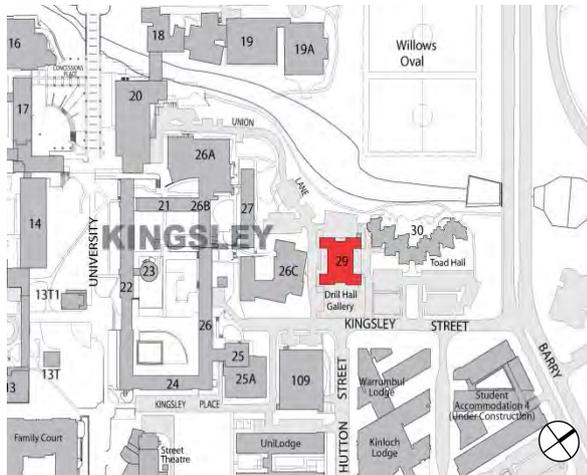
Figure 2: The Drill Hall Gallery in its context of the Kingsley Precinct, including the Manning Clark Centre (26A) to the south.

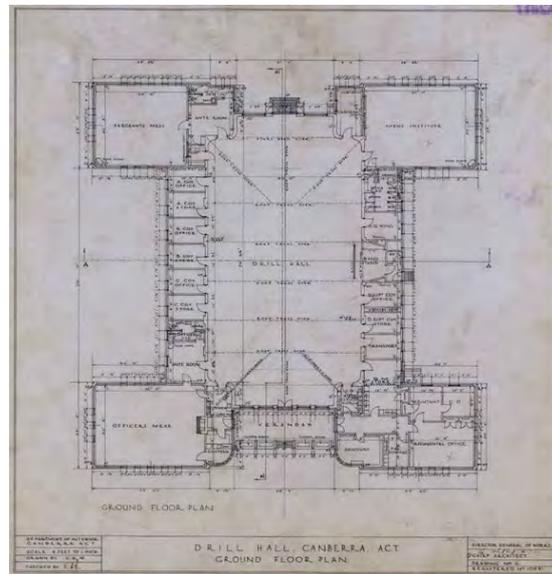
Figure 3: 1939 Site Plan of Drill Hall Gallery. (Source: NAA A2617, 2/10581)

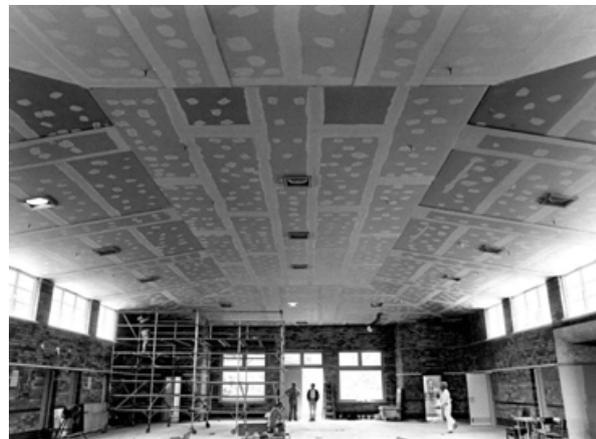
Figure 6: False walls and ceilings were added to the building when it was converted into an art gallery in the mid-1980s. (September 1984, Source: ANU Archives)

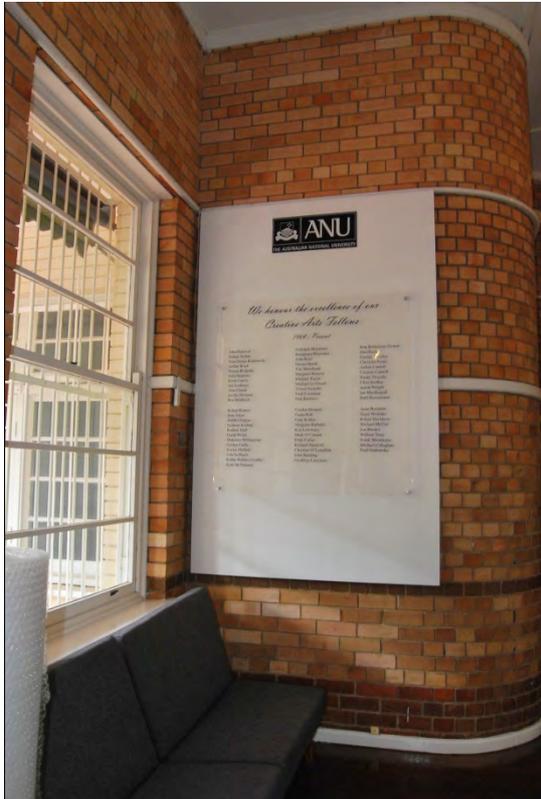
**Figure 9:** Roll of Creative Arts Fellows attached to the Drill Hall Gallery. This includes the Architectural detailing of the curved walls as a part of the original design. (Source: ANU Heritage Office, 2012)

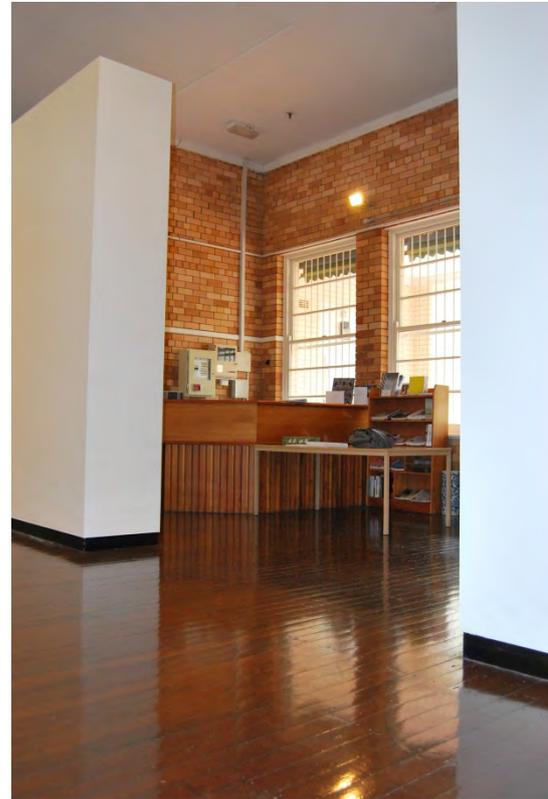
**Figure 10:** View of the timber finished front desk and resources of the Drill Hall Gallery foyer and the metal bar security screens on the exterior of the building. (Source: ANU Heritage Office, 2012)
