Australian National University

Acton Campus — Site Inventory

Study Item/ Area	Old Hospital Buildings
Acton Campus Precinct	GARRAN Precinct
Building Nos. & Names	61A (Old Hospital Building/Jaeger), 62 (M Block), 62A (M Block Extension), 63 (N Block), 63A (N Block Extension), 63T1 (CMHR Transportable 1), 63T2 (CMHR Transportable 2), 64 (Gardeners Depot), 64A (Gardeners Cottage), 64B (University General Store), 86 (Tennis Court), 86A (Tennis Shed), 97 (PCB Store)

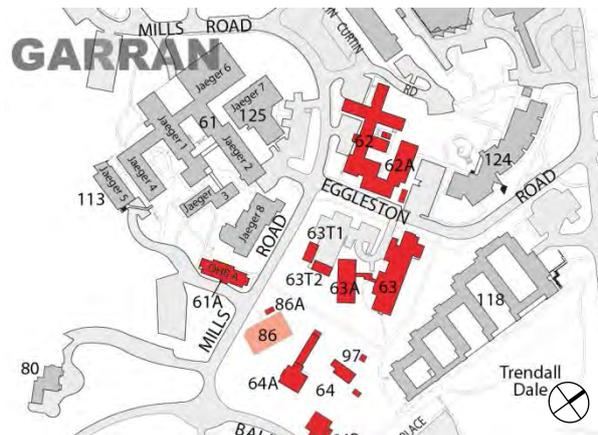
Figure 3: The configuration of the Old Hospital Buildings and their extensions.

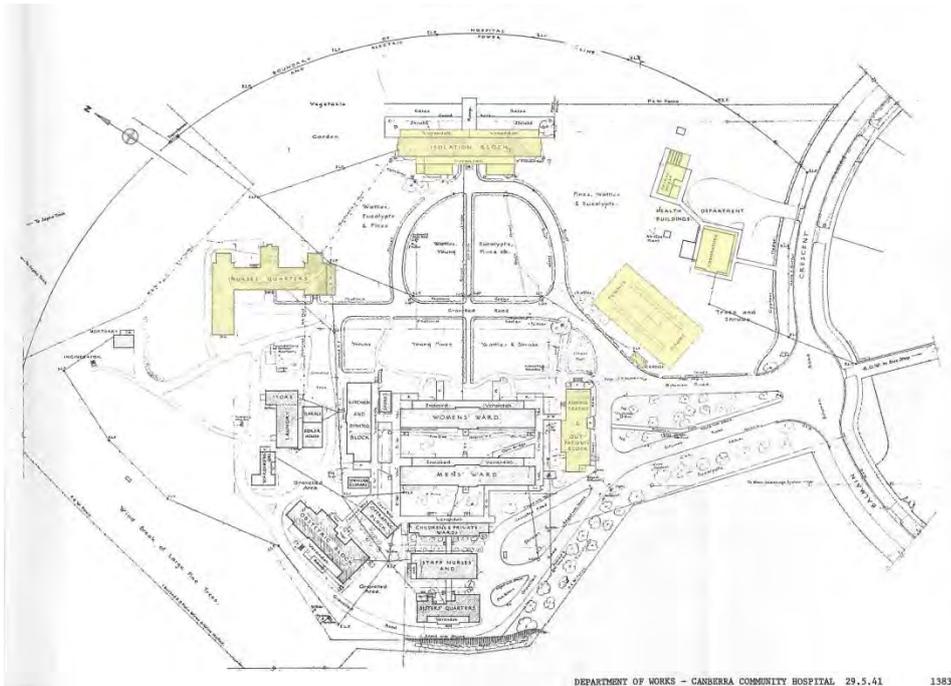
Figure 4: 1941 plan of the Old Hospital Building area. The shaded buildings represent extant buildings that have not been demolished. (Source: ANU Archives)

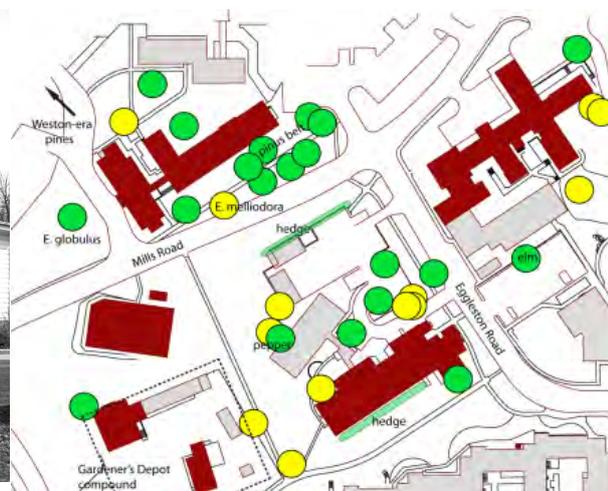
Figure 6: Layout of the Old Hospital Buildings with extant trees. (Source: Heritage Officer 2011).

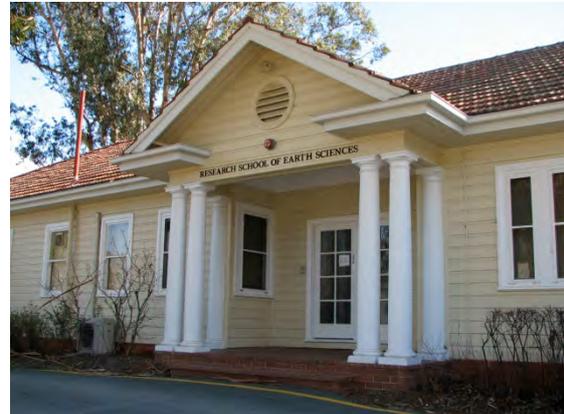
Figure 8: Entrance to the Old Administration Building. (Source: ANU Heritage Office 2011)

The double entry doors have small panes of frosted glass fitted into bulky rounded glazing bars which are typical of the period. The perimeter of the building is mostly intact; the north-east porch has been enclosed, although there are signs of the original stairs in the foundation brickwork. This element has a flat roof.

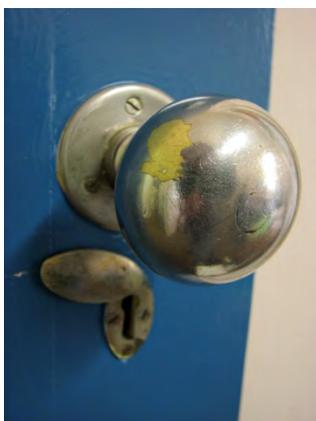
Figure 11: One of the original door handles still in functional use in the Old Administration Building (61A). (Source: ANU Heritage Office 2011)

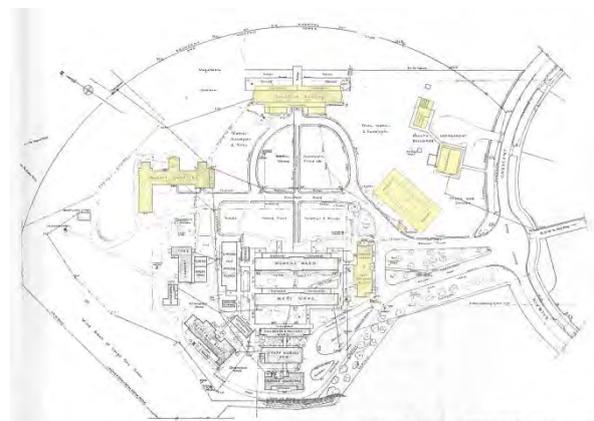
Figure 12: 1941 base plan of the Old Hospital Building area showing the extant buildings shaded yellow. (Source: Drawings Office ANU 2011)

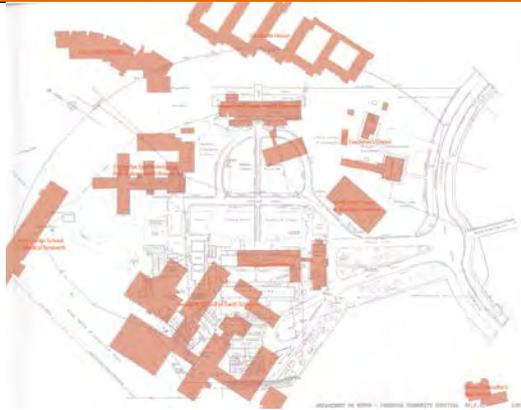
Figure 13: Superimposition of the current buildings of the OHB area over the original hospital layout. (Source: ANU Heritage Office 2011)
